Navajo Abandoned Uranium Mine

Site Screen Report

A & B No. 2 AUM Site

Weston Solutions, Inc.

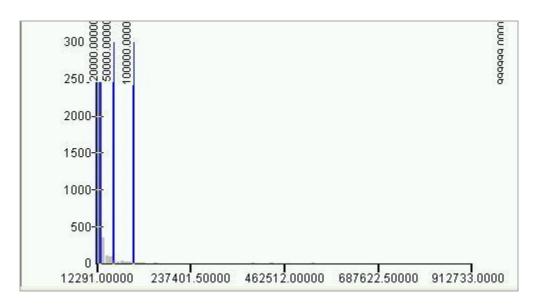
The following chart and statistics were generated by ESRI ArcGIS 9.3.1, and show the general distribution of the site gamma radiation measurements. The horizontal X axis represents the gamma radiation reading levels in cpm (lowest levels to the left). The vertical Y axis represents the frequency of each gamma radiation level.

Maximum:
 912733.00000

Mean:
 43094.56370

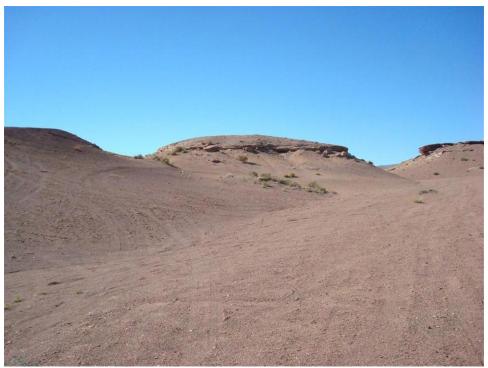
Photo 1. A & B No. 2 mine site

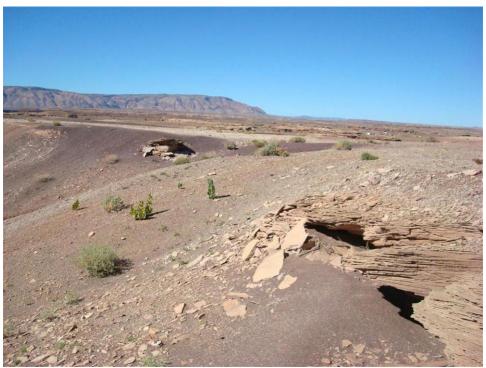
Photo 2. A & B No. 2 mine site

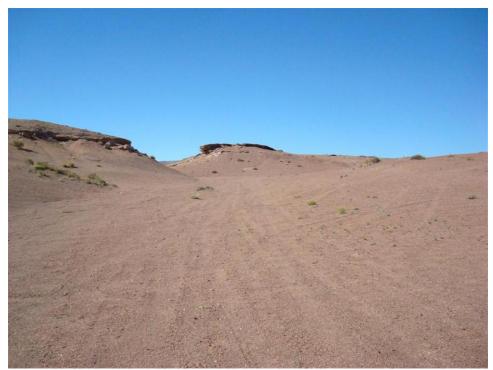
Photo 3. A & B No. 2 mine site

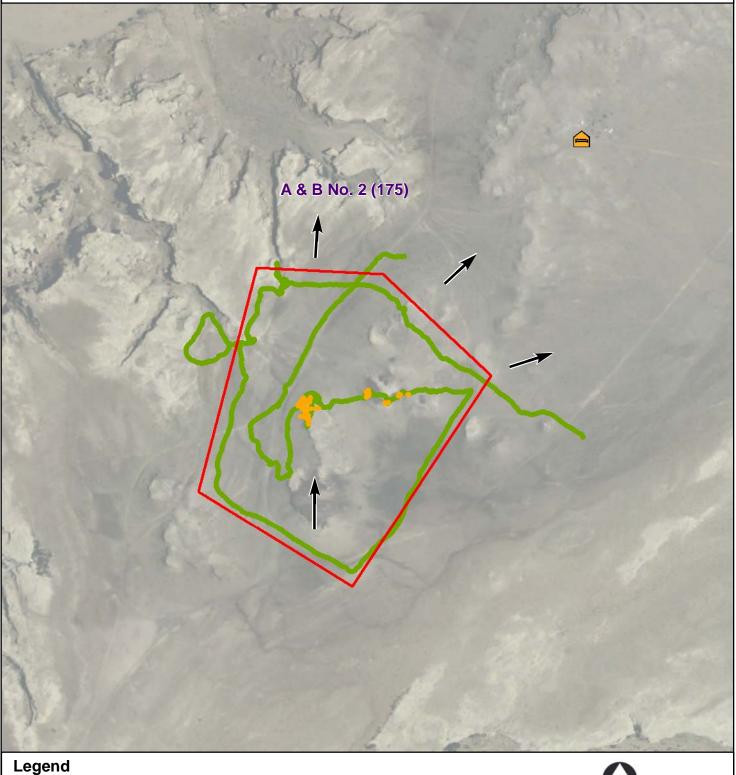
Figure 1 - Gamma Radiation Measurements, Above Two Times Background A & B No. 2 (175)

A total of 3,532 gamma radiation measurements were collected from the mine site, ranging from 12,291 cpm to 912,733 cpm. The measurements collected in the drainage channels were found at background levels, but along the sandstone bluff above the drainage at a maximum level of approximately 900,000 cpm. The measurements are represented in Figures 1 and 2.

Gamma survey conducted 11/2010 Measured as counts per minute (cpm)

Average background 18,687 cpm

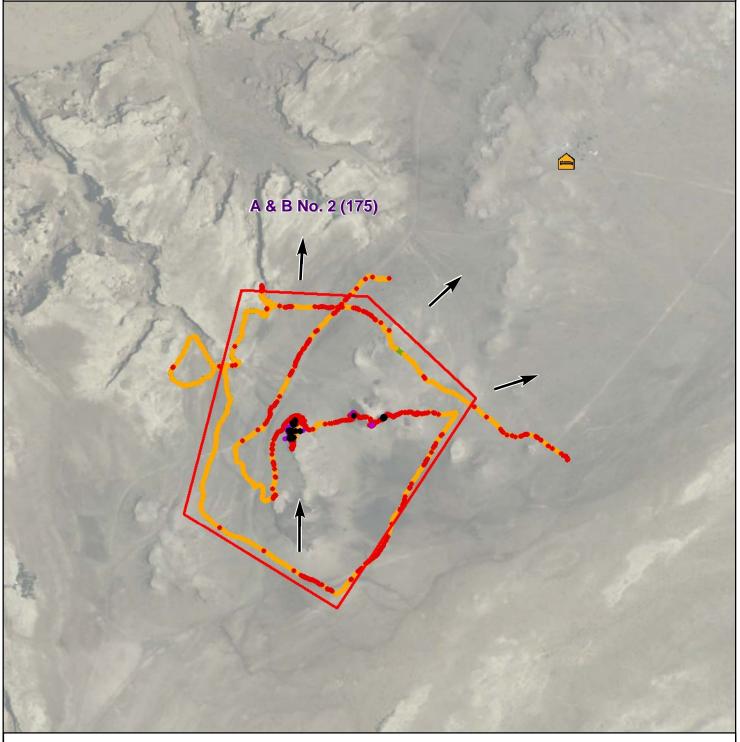
Figure 2 - Gamma Radiation Measurements A & B No. 2 (175) Cameron Chapter, Navajo Nation

Gamma survey conducted 11/2010 Measured as counts per minute (cpm)

Average background 18,687 cpm
